## Issue 110 Transit History Colour Section...

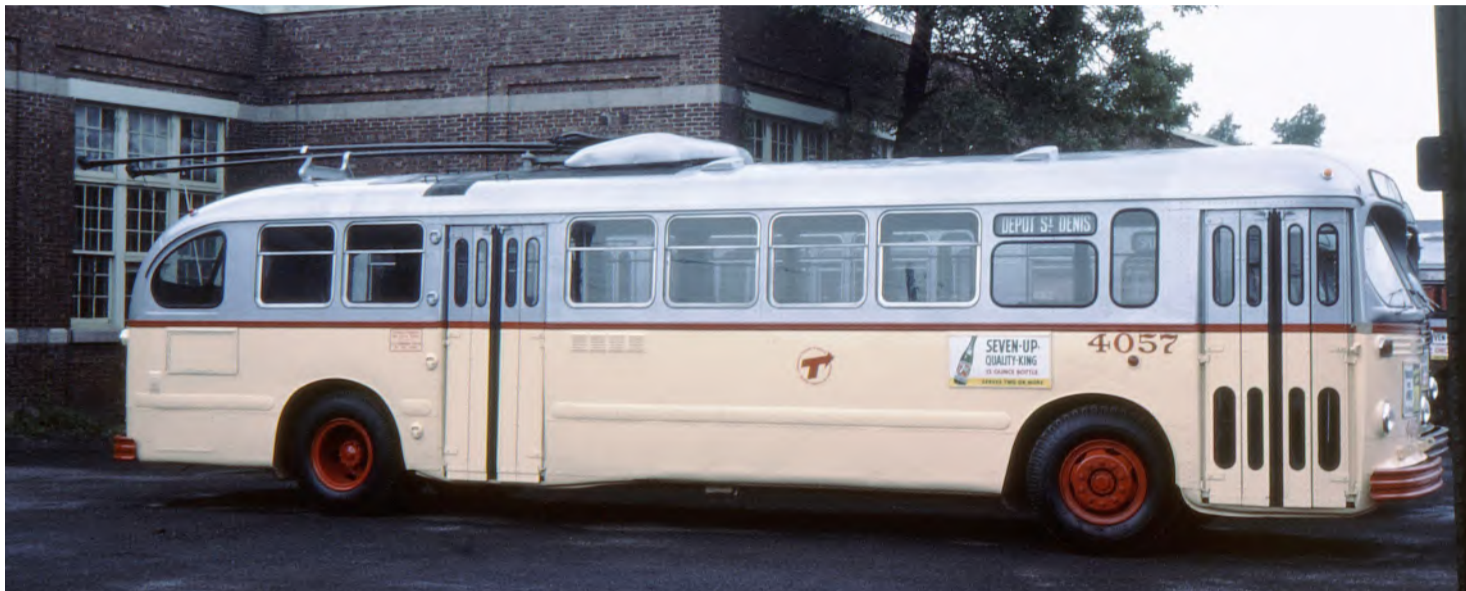
*Montreal Transportation Commission T44 number 4057 had just been outshopped from an overhaul and repaint when Peter caught it with his lens., however the system was only four years from abandonment. The trolley coaches stopped running in mid-1966, a few months before the first Metro line opened. Of the 105 CC&F Brill coaches 100, including 4057, went south to Mexico City in 1967. Photo date: June 30, 1962.*

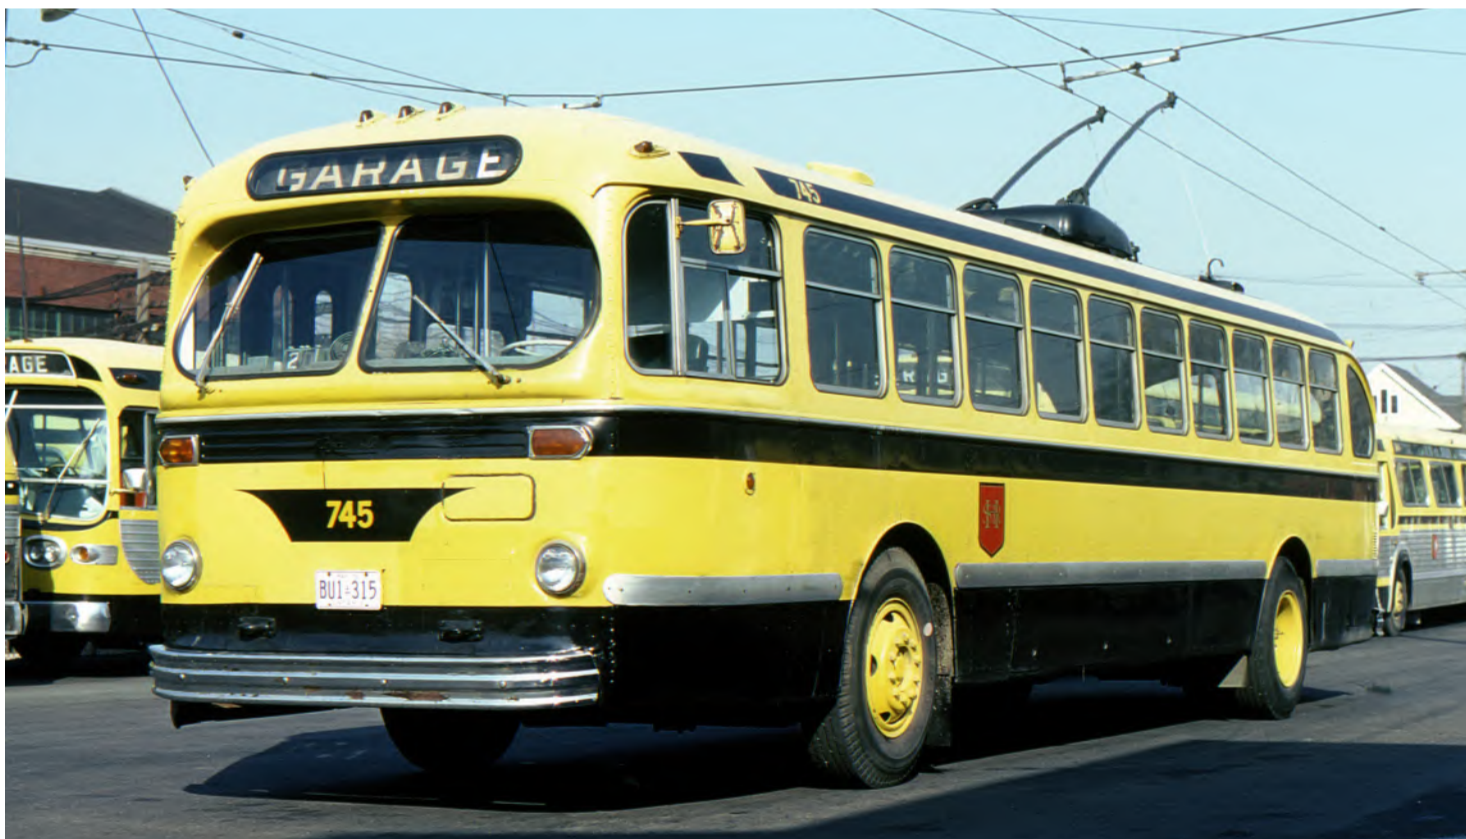
*The Hamilton Street Railway introduced their new colour scheme in late 1972 when the Flyer Industries trolley coaches started to replace the T48 and T48A Brill coaches. Coach 745 from 1951 was still in service a few years later and received a variation of the new livery. Photo date: Nov 03, 1978.*

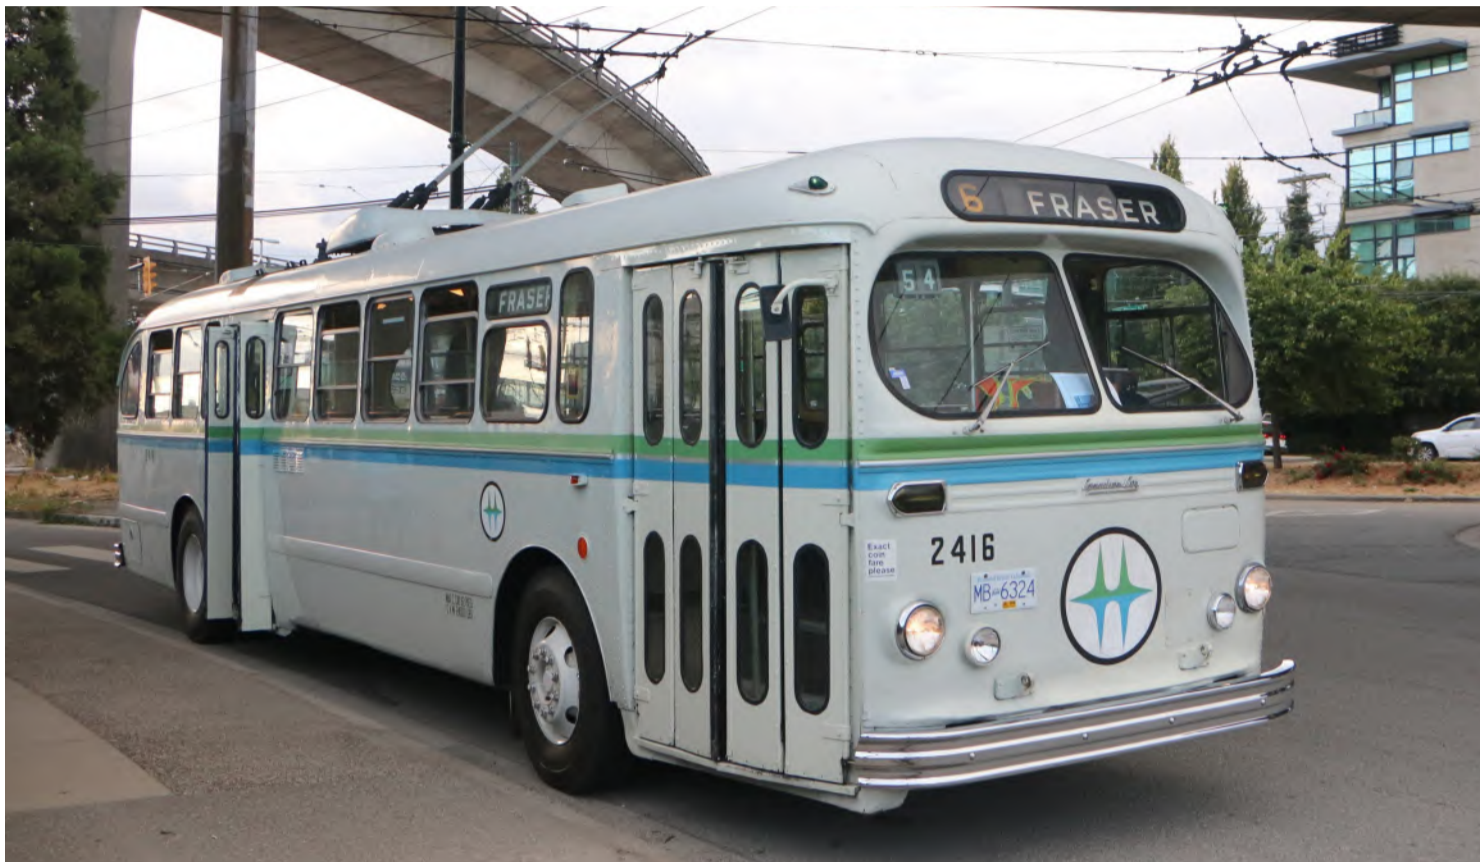
*Thanks to the Transit Museum Society (TRAMS) and Canada's last operating trolley bus system it is still possible to ride on a fully operational CC&F-Brill trolley coach today. B.C. Electric's last T48A purchased new, number 2416, is restored to running condition and makes occasional tours of the Vancouver trolley system. The 1954 coach and its companion T44, number 2040, attract a lot of attention (and the occasional confused revenue passenger) whenever they venture back onto Vancouver's streets. Operator extraordinaire Angus McIntyre piloted 2416 on this day in August of 2018. Photo: Andrew Gold*

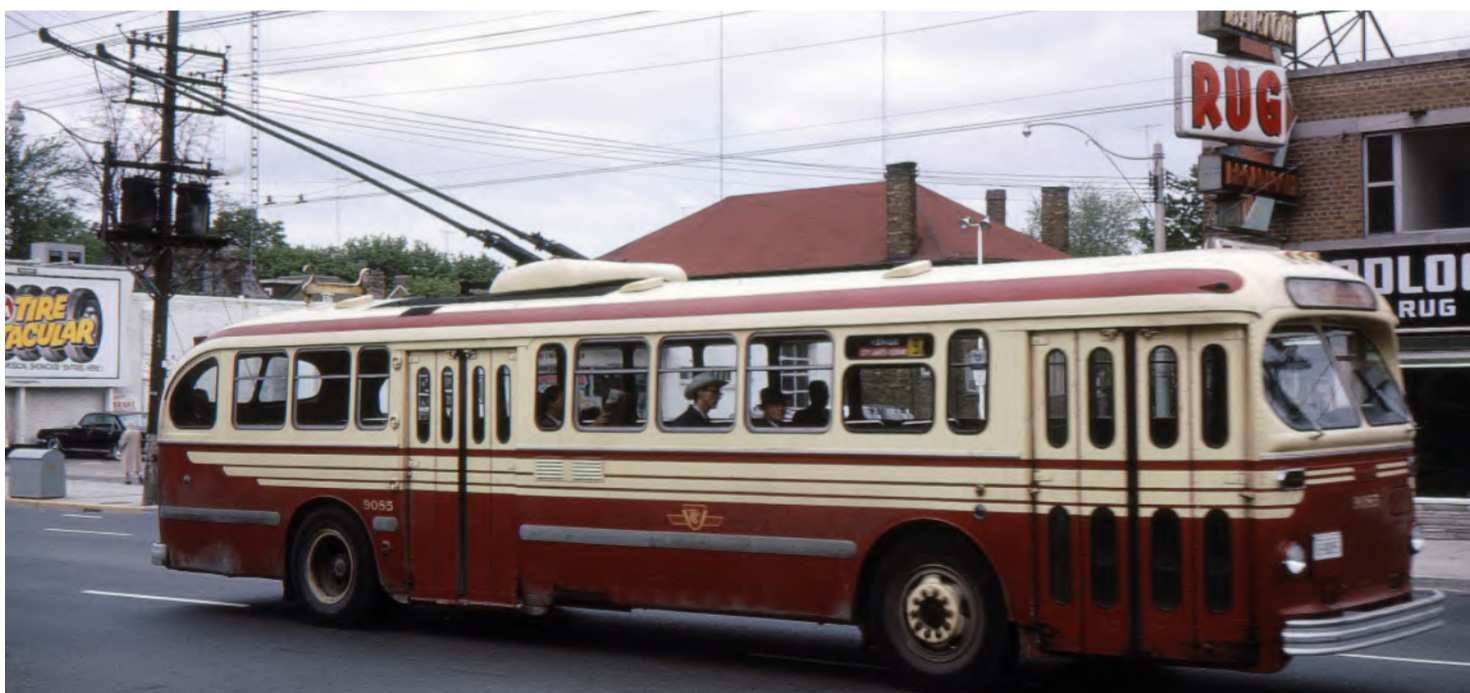
*The final order of new T48A trolleys for the TTC consisted of 40 buses of a slightly different configuration. Using the flexibility of the Brill design these 40-foot buses were built with double-width front and rear doors, resulting in a slightly different side window arrangement on the right side (and probably 2 less seats). The 9085-9124 group would have been quick to unload at busy bus stops! Photo date: May 30, 1966. Photo: Peter Cox Collection via CTHF*

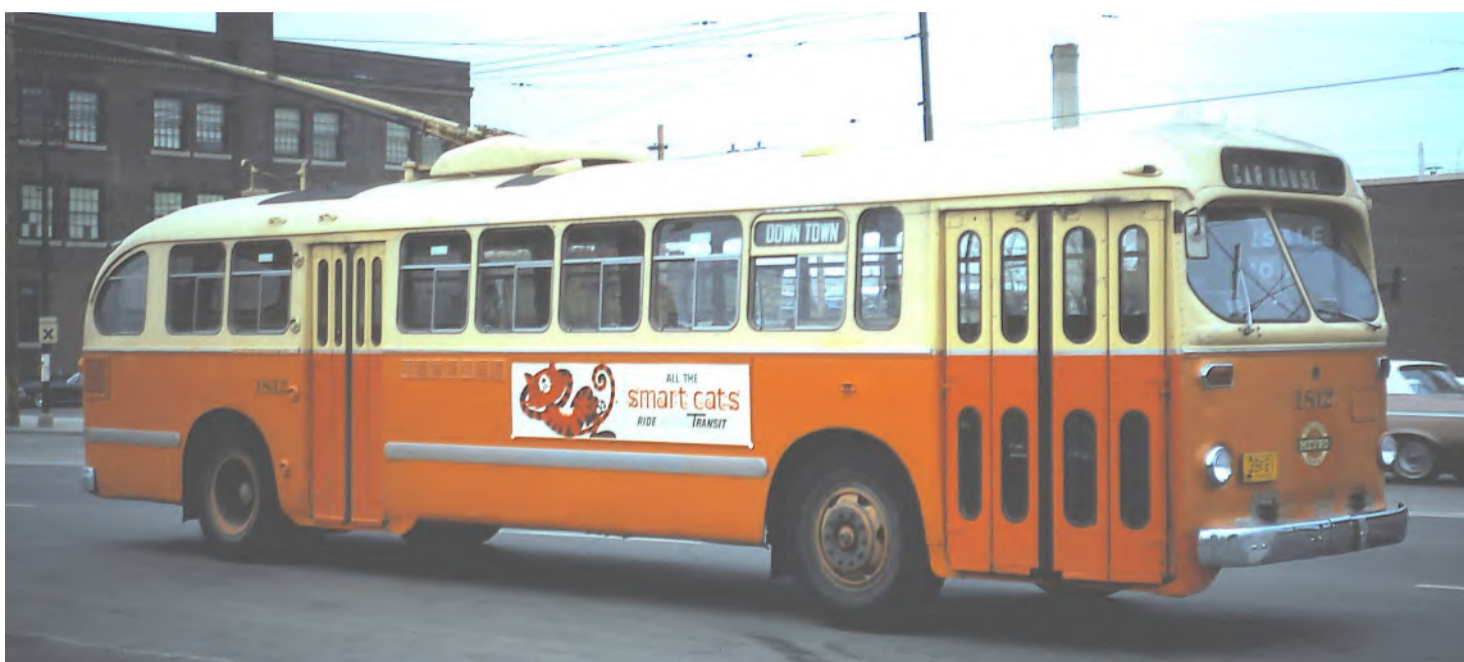
The Brill trolley model T46 was not produced by CC&F. It was essentially a T44 with an extended front platform that permitted a double-width front door and added two seats to the total capacity. This bus is an ACF T46 and is one of 10 acquired by the Greater Winnipeg Transit Commission in 1956 to expand their fleet. It was built for Flint, Michigan in 1951 and sold when that system abandoned trolley buses. The other nine buses in this group went on to be sold to Mexico City in 1969 as Winnipeg started to wind down their trolley system before ending electric operations in 1970, however this one was off the roster by then and didn't make the trip south. The nine that did go to Mexico City (only seven went into service there) operated in all three countries in North America, the only trolley coaches known to do so. Note the protruding shroud around the front destination sign, a spotting feature of ACF Brills that was not present on the CC&F products.

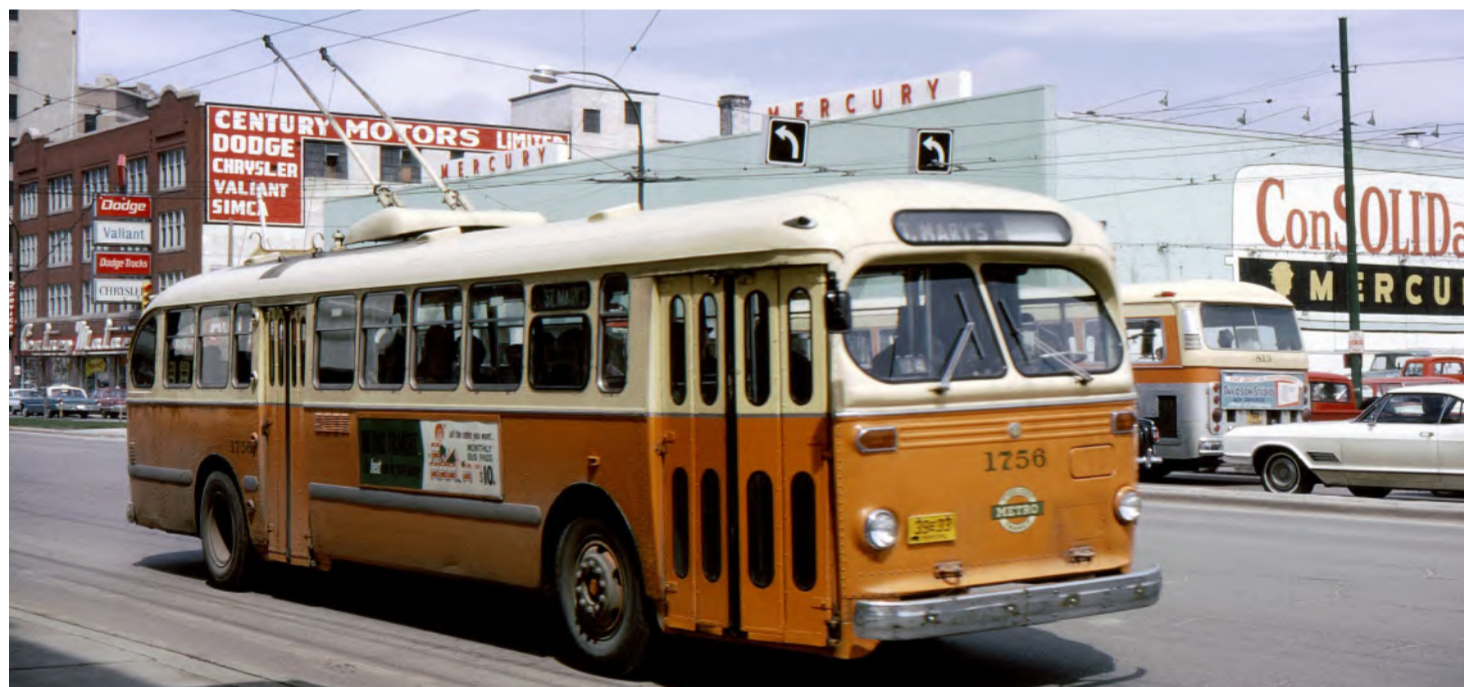
Winnipeg purchased a total of 104 new CC&F trolley coaches between 1947 and 1950. Number 1756 (Winnipeg used only even numbers on electric vehicles) was part of the final order for 30 T48A models in 1950. Though similar to the ACF-Brill T46 above the T48A is a bit longer with an additional small window behind the exit door. The ad on the side of the bus offers a monthly bus pass for \$10! The bus in the background is a Mitsubishi Fuso model MAR 750L delivered earlier that year. See the back cover of Issue 102 for a front view. Photo date: May 16, 1966.

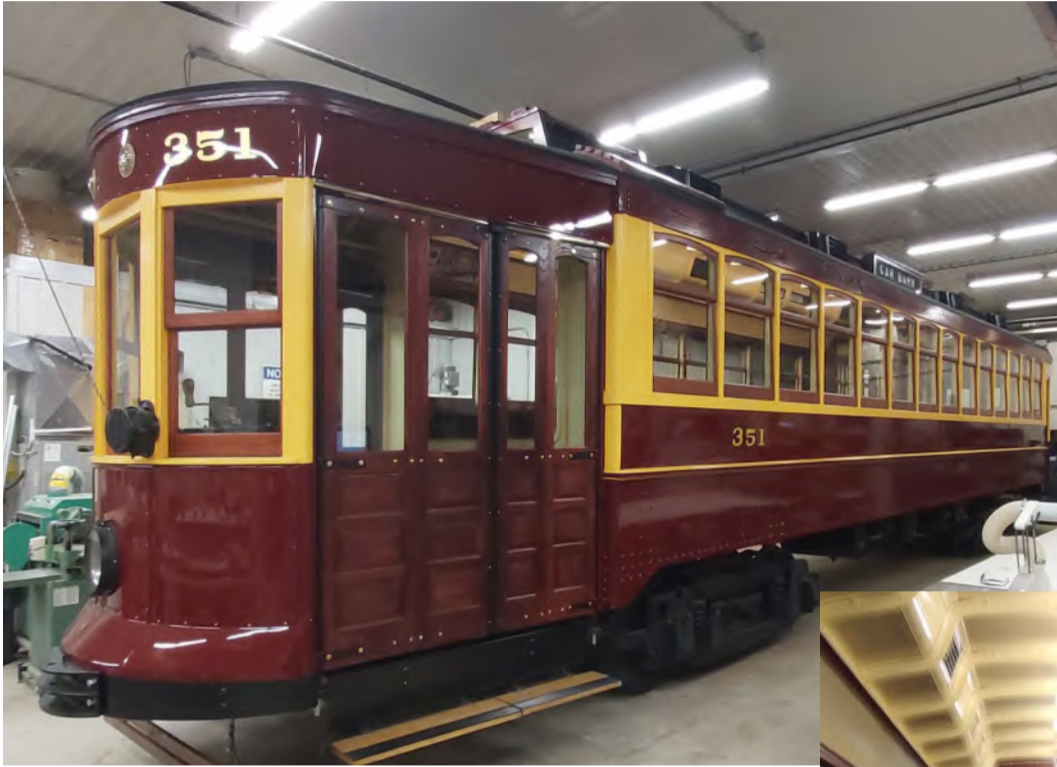
*Top: SW&A streetcar #351 restored to like-new condition. The body was stripped down to the frame for a complete rebuilding which included the construction of a new floor and underside frame. The carbody was then reassembled with new parts where the original pieces were missing or beyond repair. Preparations are now underway to create a permanent indoor public space for this car.*

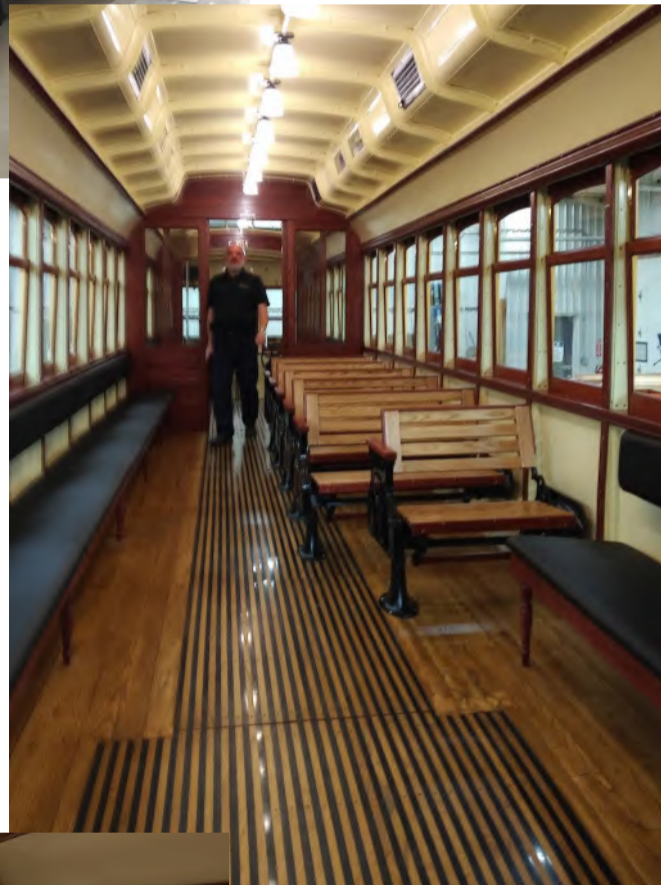
*Centre: The interior view of the car showing the utilitarian arrangement of the day. Primarily used in suburban service, this car was one of the few in the fleet which had separate smoking compartment.*

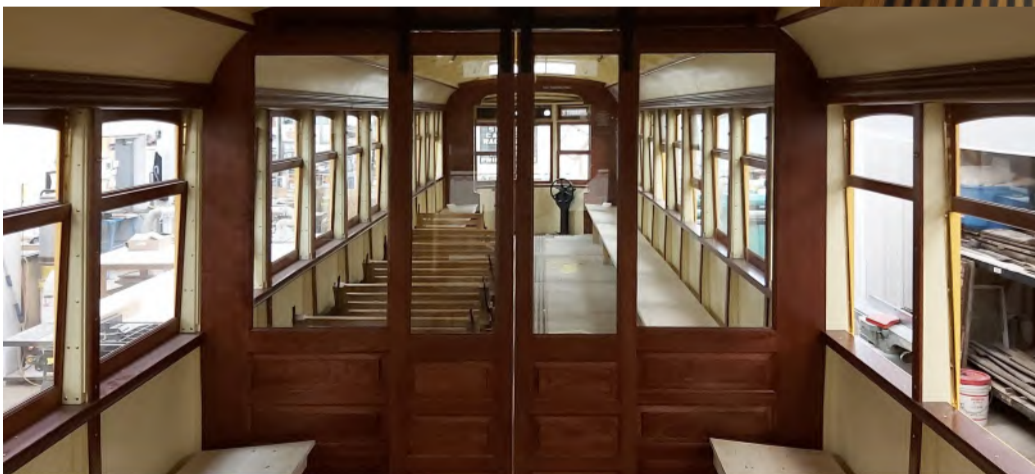
*Bottom: This is the view from the rear smoking compartment showing the doors providing separation from the main passenger cabin.*
